## **CONCRETE SWELLING OF DAMS IN SWITZERLAND**

08.05.2017

Report of the Swiss Committee on Dams on the state  
of concrete swelling in Swiss Dams

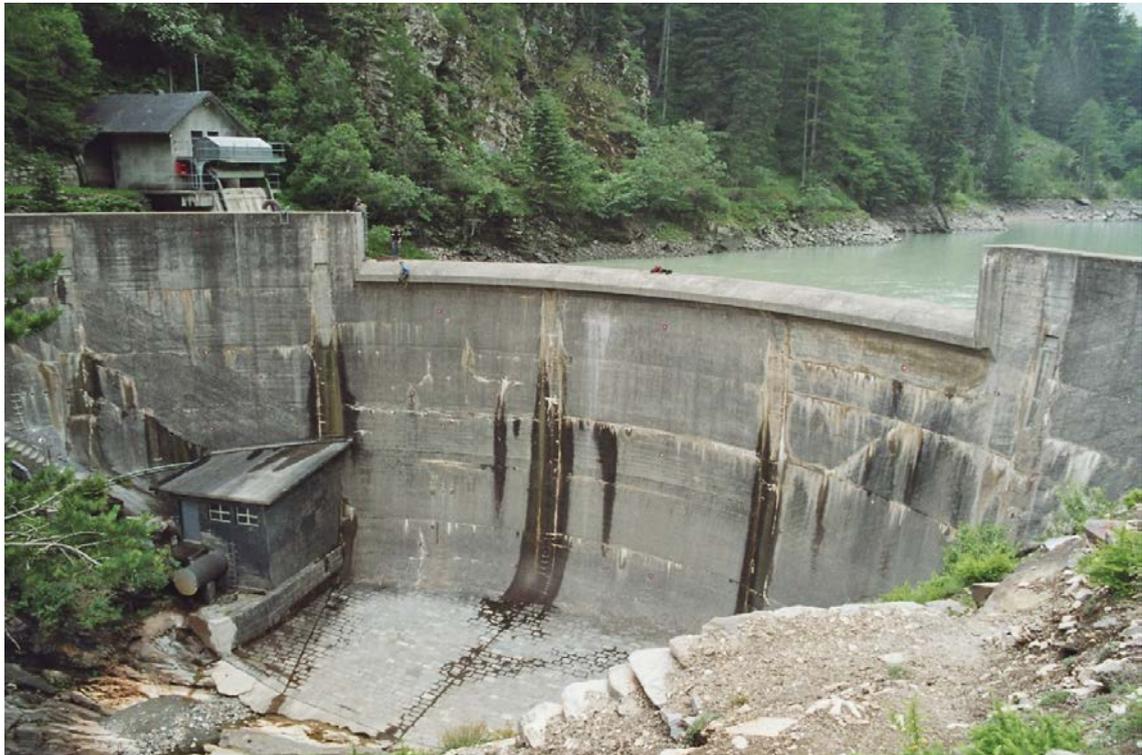
**Figure 1:** Old Sera Dam damaged by AAR at Gondo in Zwischbergental (VS).

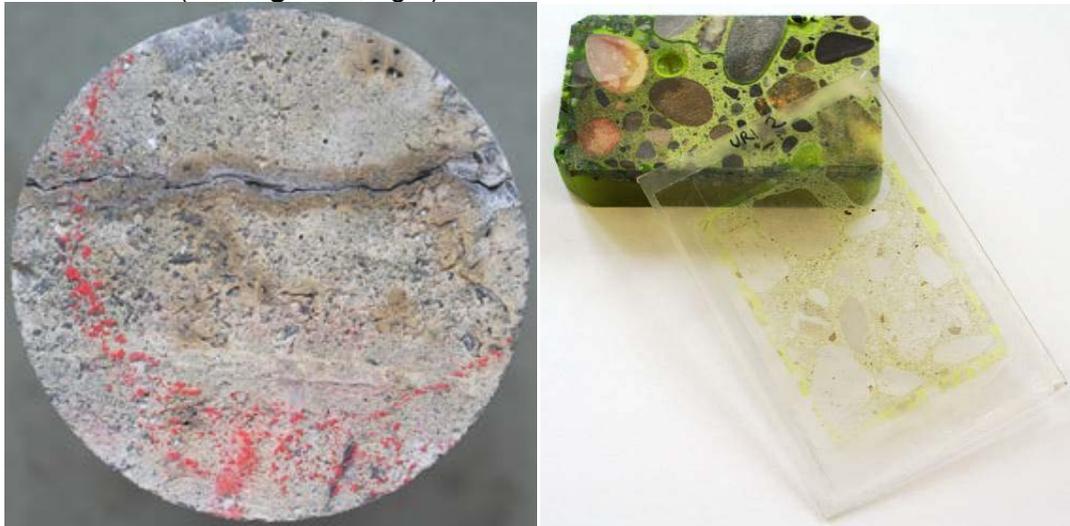
For laboratory tests, cylindrical core samples can be taken from the structure using a core drilling machine. AAR damage can often easily be recognized with the naked eye on such samples (see **Figure 6**, left and **Figure 7**). For examinations under the microscope, smaller samples must be taken from the sample cores and processed as thin sections (see **Figure 6**, right).

**Figure 6:** Surface of a drill core  $d = 100$  mm with cracks due to AAR (left) and concrete sample  $50 \times 90$  mm with impregnated thin section / thin section for observation under the light microscope (right) [10].

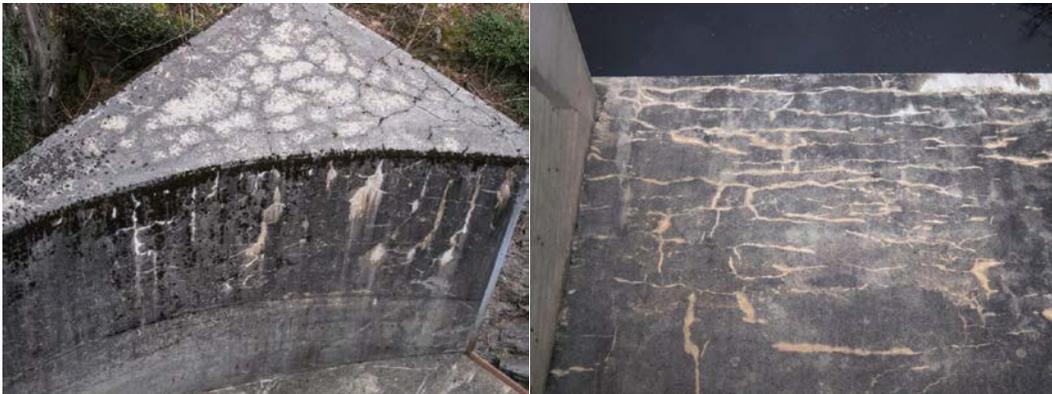
**Figure 12:** Web-shaped AAR cracks at a spillway (left) and cracks at the inlet of a spillway with prevailing crack direction due to existing forces (right).

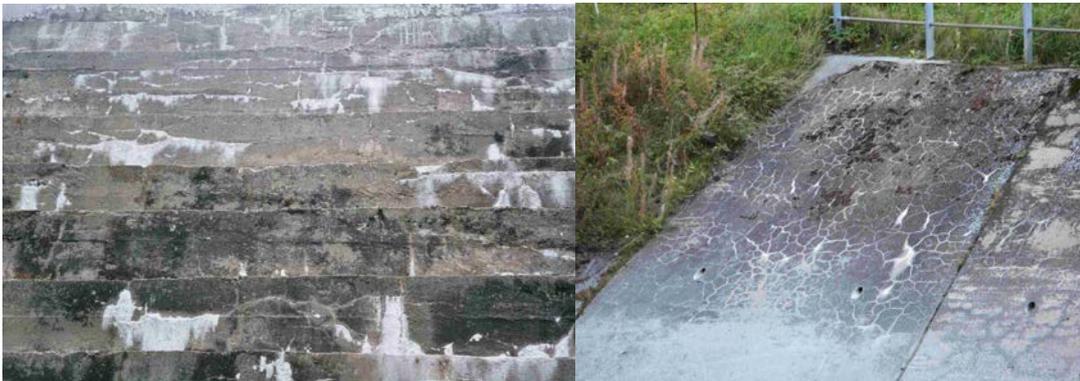
**Figure 13:** AAR cracks with strong air-flow efflorescence at downstream face of a stepped gravity dam (left) and shore protection in the underwater area of a weir with clearly shaped AAR cracks (right).

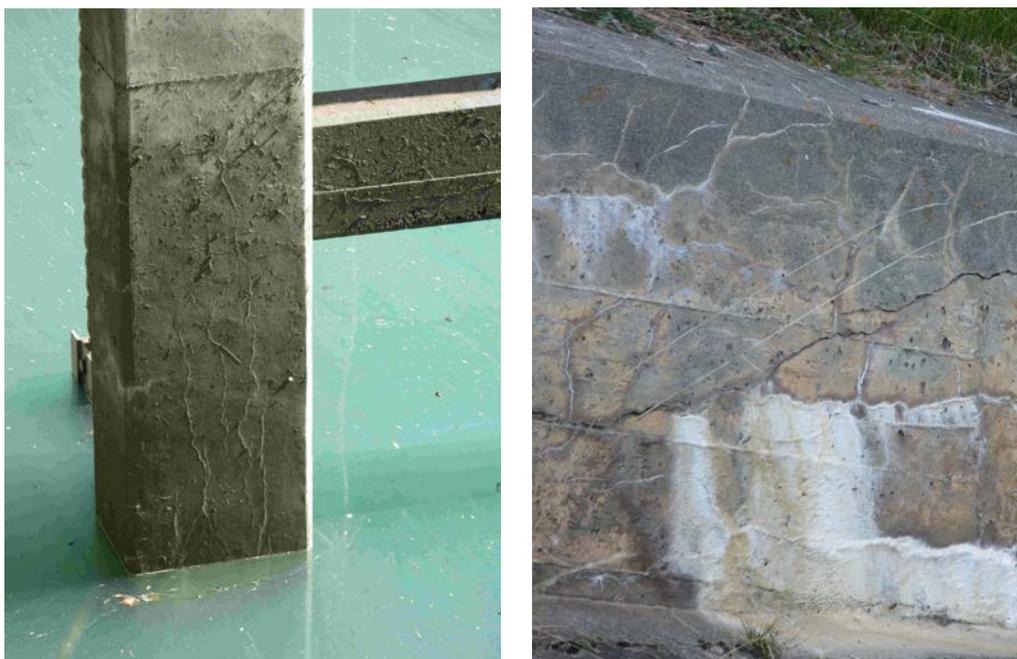
**Figure 16:** Support of a reinforcement bar with AAR cracks in the main vertical stress direction (left) and retaining wall of a surface spillway with gaping crack (right).

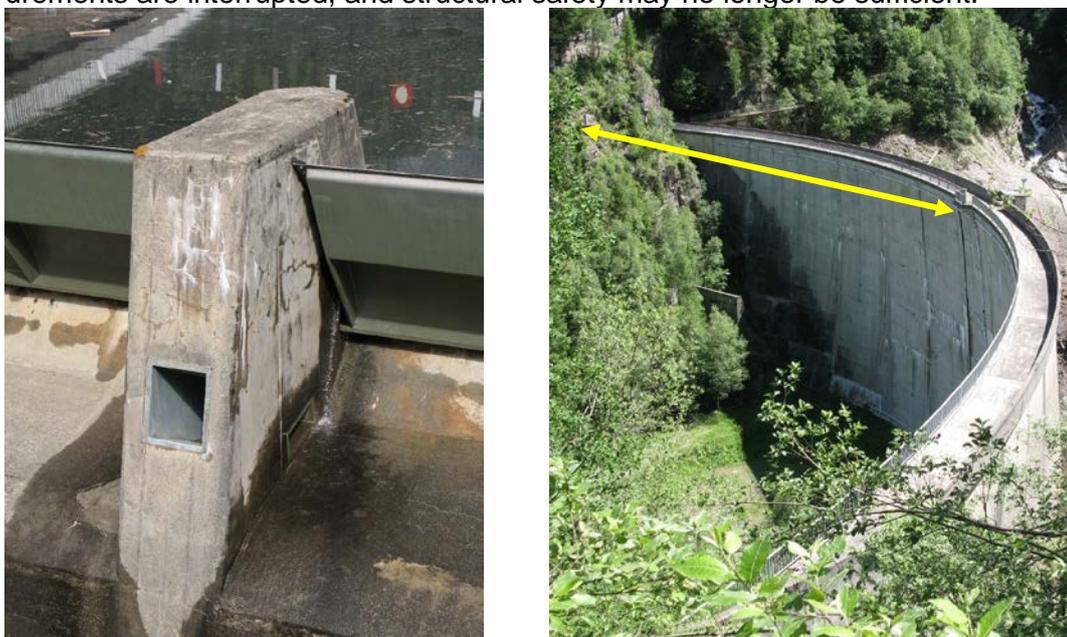
As shown in **Figure 17** to **Figure 19** below, the safety of a dam due to AAR can be impaired in several ways (see also [13]). Blocking of gates can occur, geodetic measurements are interrupted, and structural safety may no longer be sufficient.

**Figure 17:** Gate mechanisms can no longer be operated due to AAR generated swelling (left) and geodetic monitoring might be interrupted due to AAR rising of the railing on the dam crest (right).

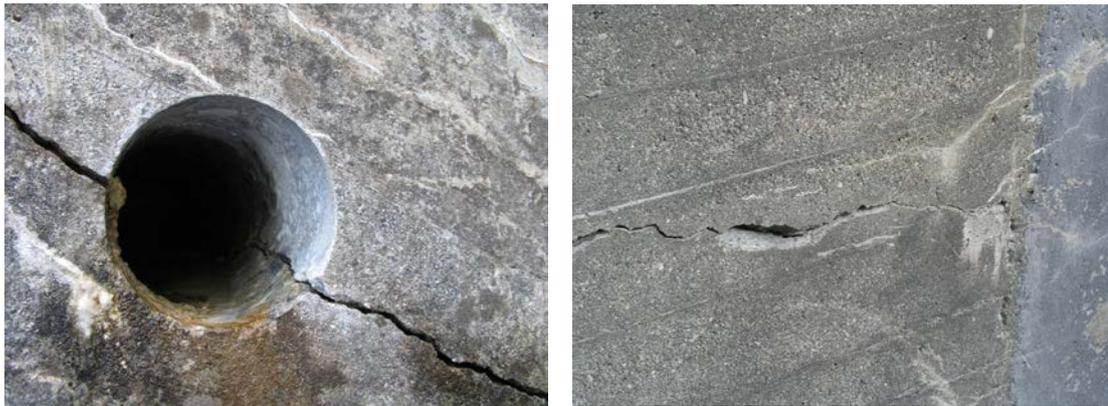
**Figure 18:** Determination of the depth of a structural crack on the downstream face of an AAR affected arch dam by drill core removal (left), and crack with filling on the upstream face of an arch dam.

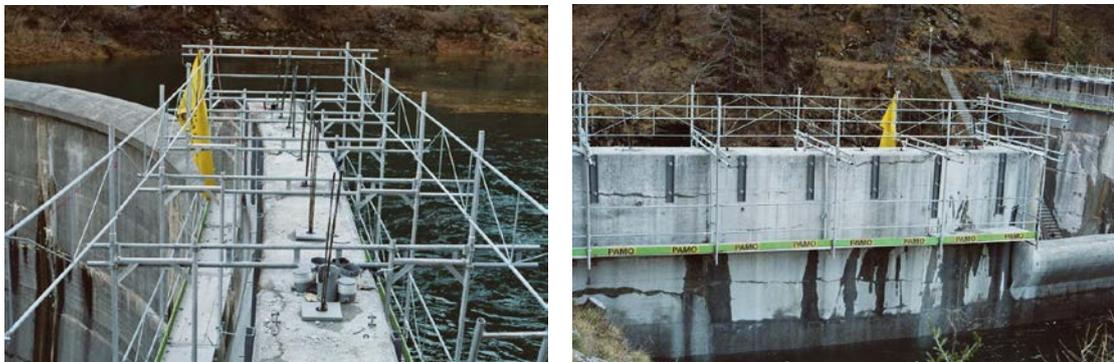
**Figure 19:** Provisional securing of an AAR-damaged dam crest with vertical tensioned anchors, and steel side straps in case of floods and earthquakes.

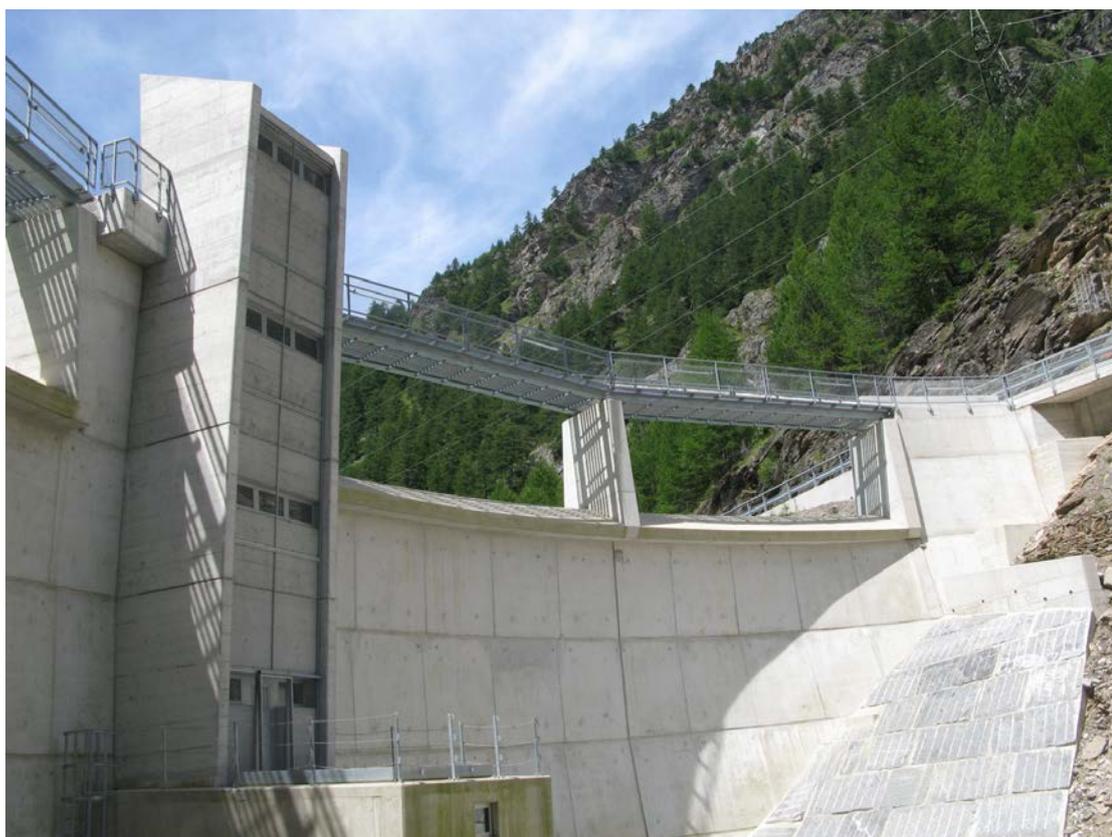
During the construction of the Sera Dam, which took place between September 2009 and December 2010, the non-reactive aggregate supplement for the concrete was transported from a quarry near Brig (VS) by lorry over the Simplon Pass to the construction site in the Zwischbergen valley near Gondo VS.

**Figure 22:** Newly constructed Sera Dam in Zwischbergental near Gondo (VS) with non-reactive aggregate concrete [17].

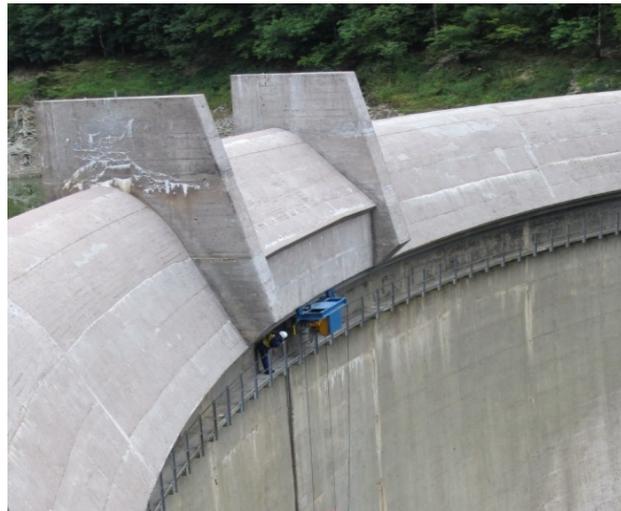
**Figure 54:** View of the guiding walls: horizontal fissuring.

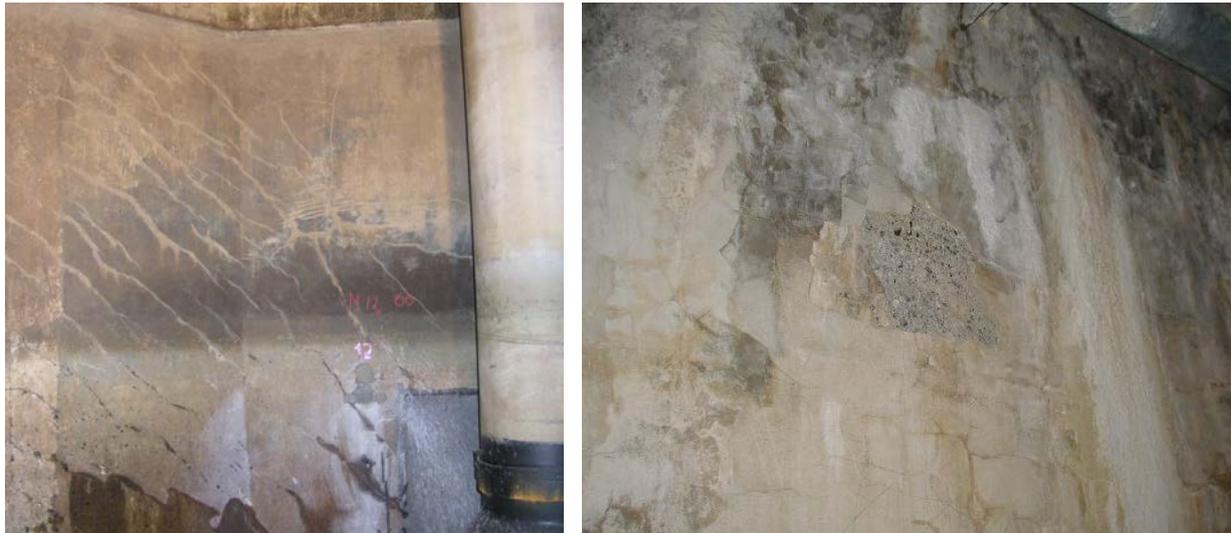
**Figure 61:** Surface condition of certain walls of submerged parts of the power plant.

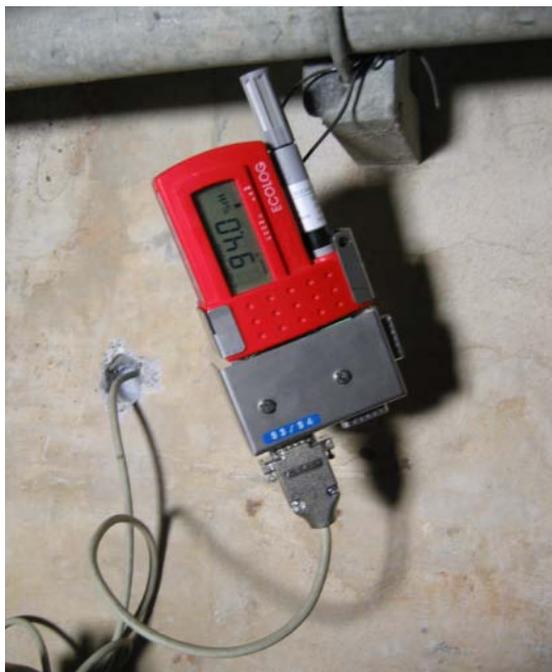
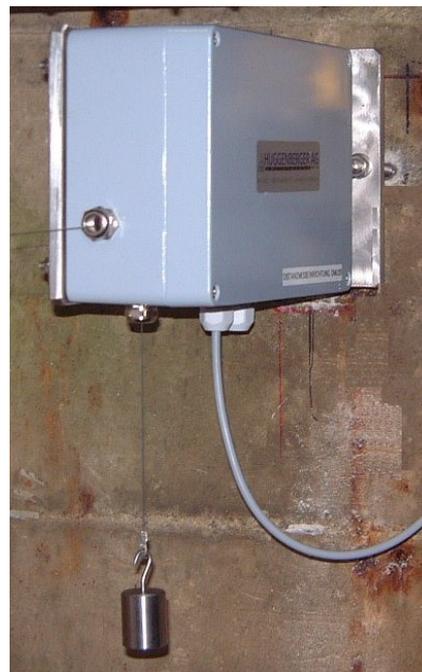
**Figure 63:** Continuous temperature and relative humidity measurements - invar wire deformation measurements.

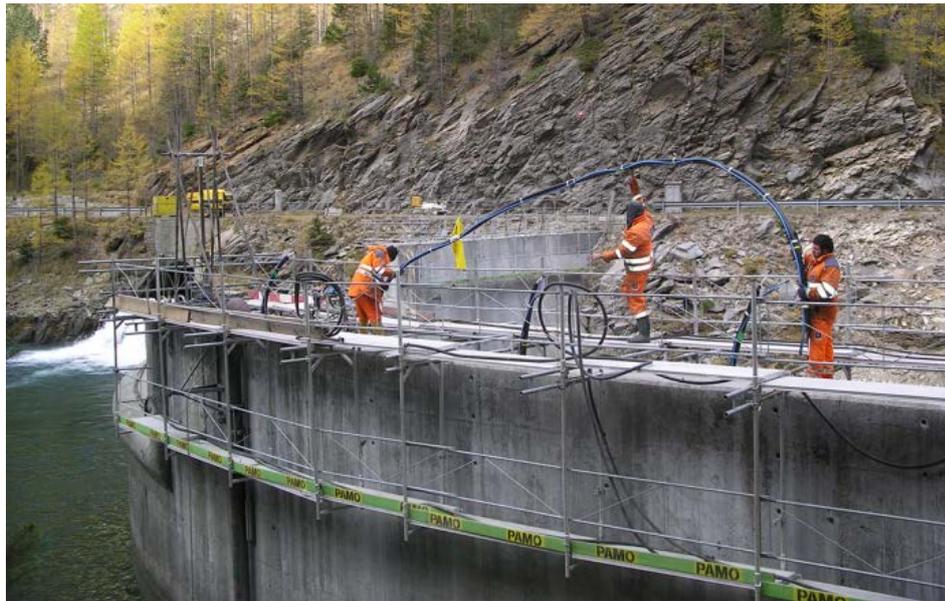
**Figure 68:** Temporary reinforcement – set-up of the vertical tension anchors.

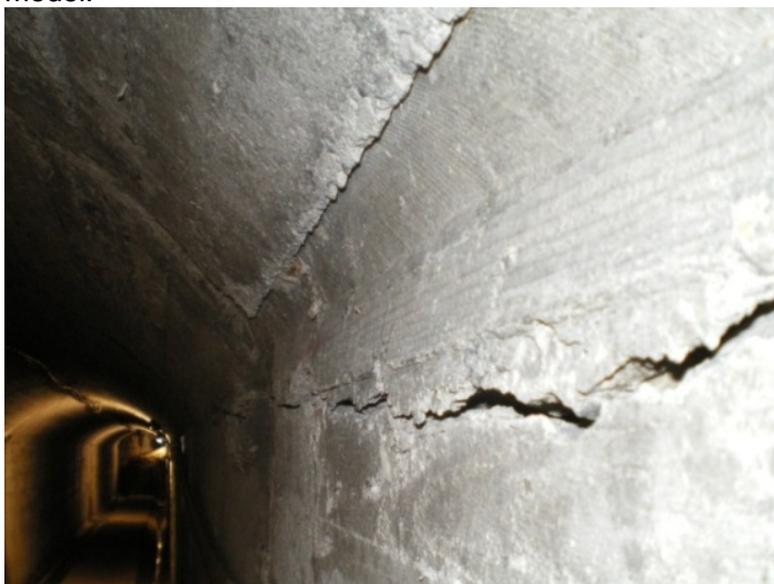
**Figure 77:** Tunnel at the base – Fissuring.

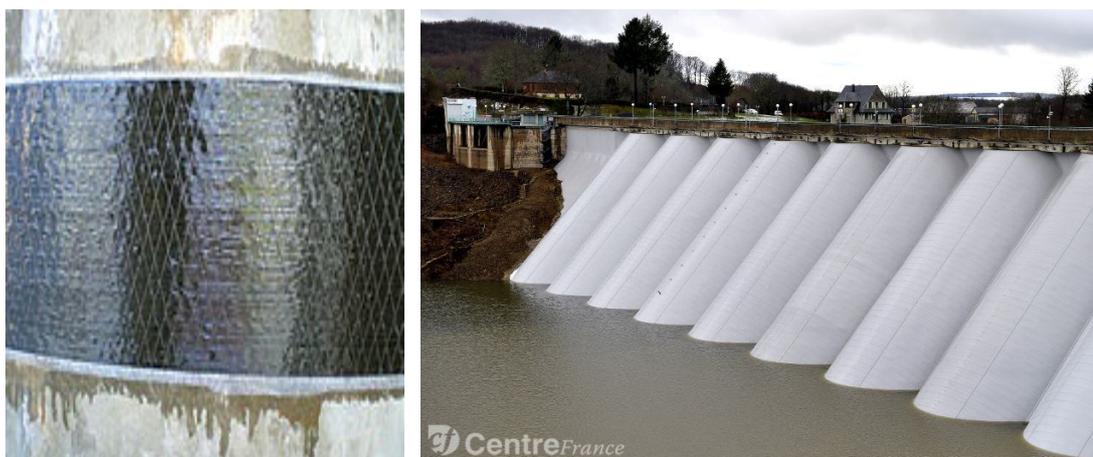
**Figure 83:** Examples of mitigation measures: a) carbon fiber protection; b) protection with PE membrane.
