Schweizerisches Talsperrenkomitee Comité suisse des barrages Comitato svizzero delle dighe Swiss Committee on Dams

FLOATING DEBRIS AT RESERVOIR DAM SPILLWAYS

Report of the Swiss Committee on Dams on the state of floating debris issues at dam spillways

November 2017

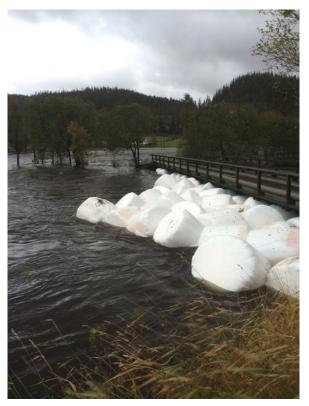
Figure 1: Obstructed spillway due to silo bales in Trondelag, Norway (Foto: L. Lia, NTNU).

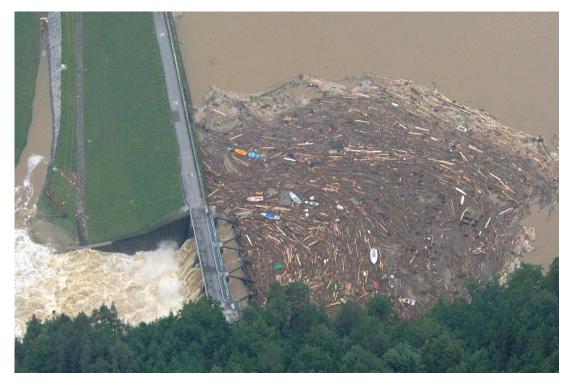
Figure 2: Floating debris in front of the Thurnberg dam spillway on the Kamp river in lower Austria during the extreme flood in 2002 (Photo: Federal Office for Agriculture and Forestry, Environment and Water Management, Austria).

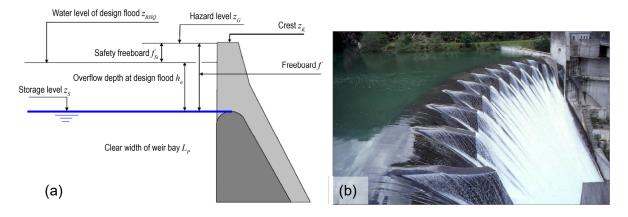
Figure 3: Schematic diagram of free overflow dam spillway inlet structure without weir bridge / superstructure, (b) dam spillway of the Palagnedra dam, Switzerland (Foto: Helga Ammann).

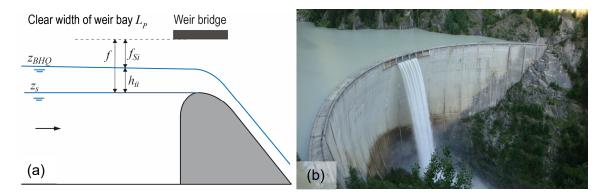
Figure 4: (a) Schematic diagram of free overflow dam spillway inlet structure with weir bridge / superstructure, (b) spillway outlet structure at the Gebidem dam, Valais, Switzerland (Photo: VAW).

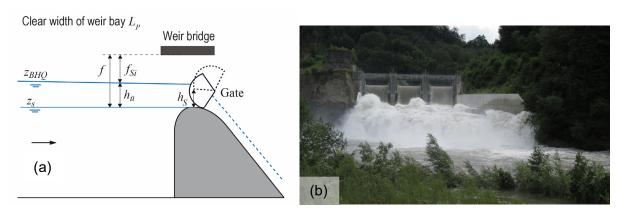
Figure 5: (a) Schematic diagram of a regulated overflow, (b) gate-regulated spillway of the Maigrauge dam, Switzerland (Photo: Group e).

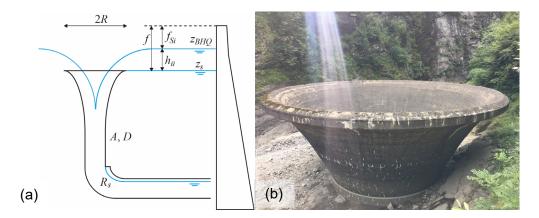
Figure 6: (a) Schematic diagram of a bell-mouth dam spillway (b) bell-mouth spillway at Malvaglia dam, Switzerland (Source: VAW).

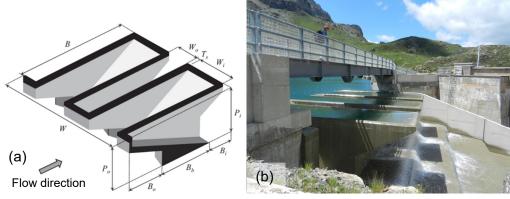
Figure 7: (a) Schematic diagram of the piano key weir spillway inlet structure, (b) Piano key weir spillway of the Gloriette dam in France (Photo: La Fourmi des Montagnes)

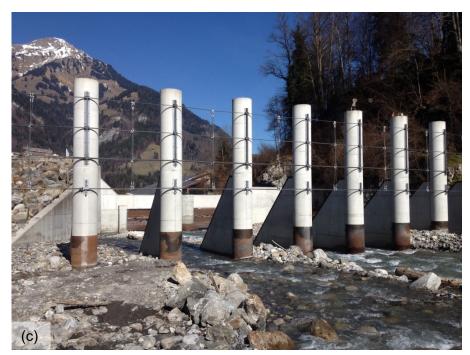
Figure 9: Large wood retention by means of (a) trash rack at the retention basin in Sachseln, canton Obwalden (photo: VAW), (b) cable net at Faukengraben, Upper Bavaria, Germany (photo: Institute for Hydraulic Engineering and Water Resources Management, TU Munich) and (c) Combination of large wood and trash cable racks on the Chiene river, Canton Bern (Photo: Emch + Berger AG).

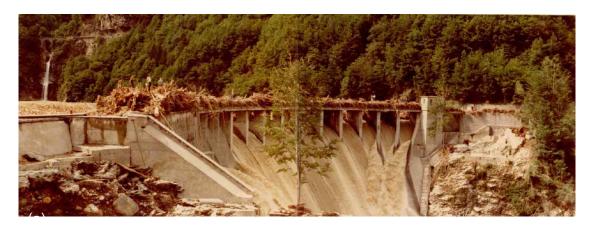
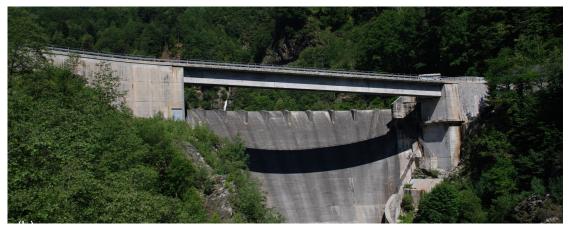
Figure 10: (a) Blocking of the dam spillway inlet structure (spillway with weir bridge) at the Palagnedra dam, Canton Ticino, 1978; (b) new dam spillway inlet structure without weir bridge (Photos: Ofima).

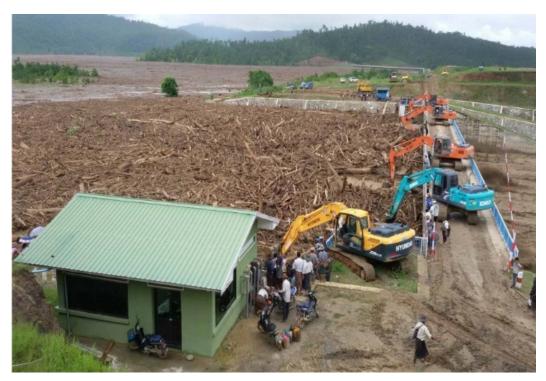
Figure 11: Removal of floating debris with excavators at the Yarzagyo dam, during the 2015 flood in Myanmar (Photo: M. Wieland).

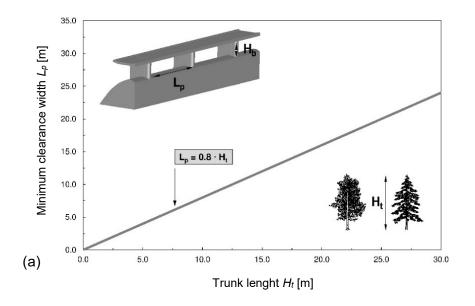
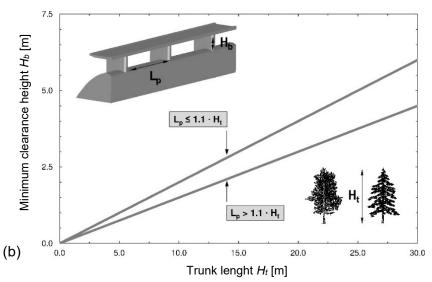
Figure 12: Characteristics for determining (a) minimum clearance width of weir bay L_p ; (b) minimum clearance height of weir bay H_b .

The SFOE (2016) gives recommendations for the minimum clearance width L_p and the minimum clearance height H_b of the individual dam spillway openings as a function of the expected tree length H_t (**Figure 12**):

These recommendations are based on the study by Godtland & Tesaker (1994). The expected tree length H_t can be estimated in the field on the basis of the prevailing forest stand. The corresponding information can also be found in the Swiss National Forest Inventory (www.lfi.ch). Alternatively, observed tree lengths in past floods can be taken as a reference (Bezzola & Hegg 2007, 2008).

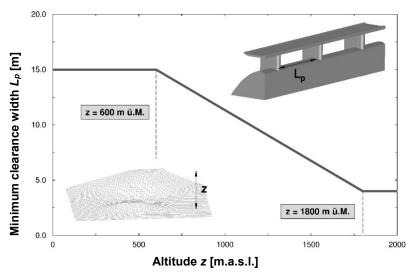
Figure 14: Minimum required clearance width of weir bay L_p as a function of altitude z of the dam (according to Cfbr 2013).

For newly built structures, a minimum clear width of the weir bay of 10 to 15 m is recommended. According to Cfbr (2013), when determining the required weir width L_p , the altitude z [m a.s.l.] of the dam must be taken into account (**Figure 14**):

$$L_p \ge 15 \text{ m}$$
 for $z \le 600 \text{ m.a.s.l.}$ (4a)
 $L_p \ge 20.5 - 11z/1200$ for $600 < z \le 1800 \text{ m.a.s.l.}$ (4b)
 $L_p \ge 4 \text{ m}$ for $z > 1800 \text{ m.a.s.l.}$ (4c)

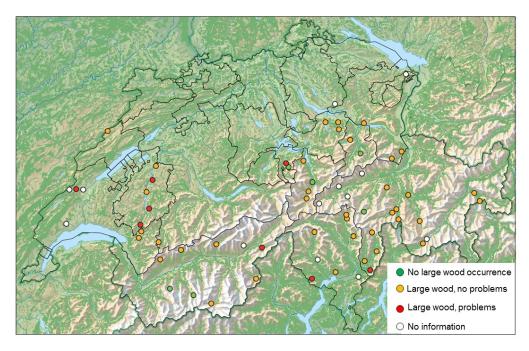
Figure 15: Results of the dam operator survey; no feedback was received from eight dam operators.

- At 46 out of 52 dams (88%), LW occurs;
- LW is removed at 32 of these 46 installations (70%);
- At 18 of these 46 installations (39%), LW is discharged through dam spillways (of which 7 of these installations also remove floating debris);
- Debris removal volumes are known at 5 installations;
- LW dimensions are known at 7 installations (of which the volume is also known at one installation);
- At 8 out of 52 installations (17%) problems (usually obstructions) have already been reported, and at 5 installations damages have been reported.

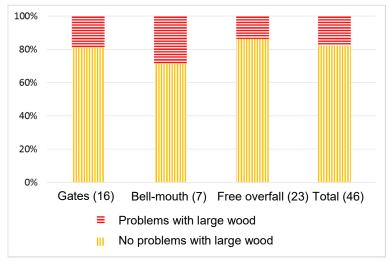
Figure 16: Influence of dam spillway type on the occurrence of problems due to LW. Number in brackets: No. of dams with respective spillway type.

- Bell-mouth spillways generally present more problems than other dam spillway inlet types. Free overflow systems are the least troublesome. A higher risk of obstruction is to be expected at bell-mouth spillways due to their construction design.
- Problems related to LW occurred regardless of the catchment area size. However, larger catchment areas see a greater number of problems, as the LW accumulation potential increases with catchment area size among other factors (section 5.1.1). Since small volumes of LW can already lead to problems at dam spillways, the hazard potential for the latter in small catchment areas is not necessarily lower.
- Dams at lower altitudes are generally more vulnerable. The reasons for this are twofold: there is typically a larger forest cover in the catchment area, and larger tree lengths can be expected at lower altitudes.

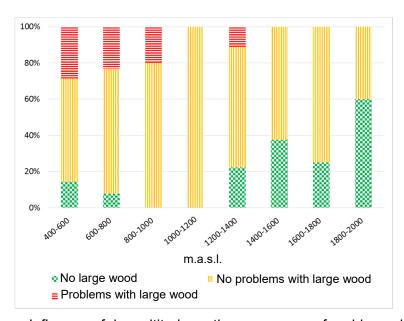
Figure 17: Influence of dam altitude on the occurrence of problems due to LW.

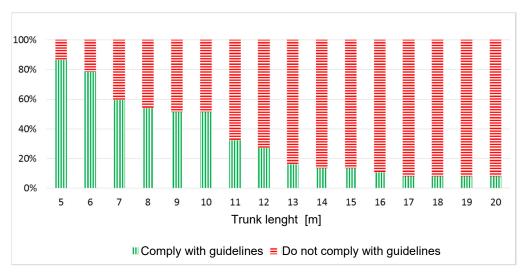
Figure 18: Percentage of dam spillways that comply or do not comply with the Swiss Guidelines (SFOE 2016) on minimum weir bay width, respectively, as a function of expected trunk lengths.

According to the survey, 17% of dams in Switzerland have experienced problems and damages due to LW (see above). In order to further estimate the existing hazard potential, the recommended dam spillway minimum dimensions according to the existing guidelines (chapter 3) can be compared with the actual dimensions. **Figure 18** shows the proportion of dam spillways that meet the required minimum width according to the Swiss Directive ($L_p \ge 0.8H_t$). Expected trunk lengths between 5 and 20 m were considered. With trunk lengths of 10 m, only about 50% of dam spillways fulfill the recommendations of the Swiss Directive. With trunk lengths of 15 m, there are only just under 15% of directive compliant dam spillways. A high dam spillway obstruction hazard potential therefore exists in case of a flood occurrence with a high amount of LW with long trunks.

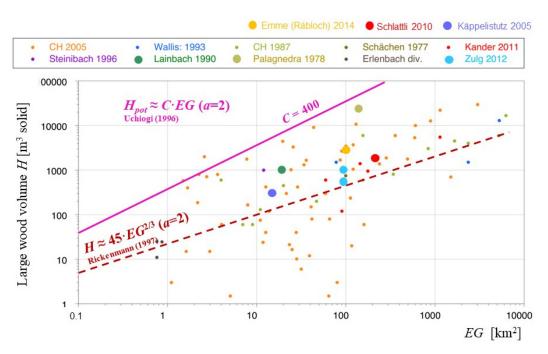
Figure 19: Observed solid large wood volumes in past flood events and estimation formulas according to Rickenmann (1997) and Uchiogi (1996) (bulk factor a = 2).

Analysis of past flood events regarding the actual entrained LW volume provides good indications for assessing hazards. If no flood events with LW entrainment are known in the catchment area under consideration, data from comparable catchment areas with similar hydrology, topography and forest cover conditions can be used. Results of observed LW volumes in Switzerland can be found in the analysis of the flood events of 1987 and 1993 (Rickenmann 1997), and 2005 (Bezzola & Hegg 2008). **Figure 19** shows observed LW volumes (solid volumes) depending on the catchment area, as well as the envelopes of Uchiogi et al. (1996, equation 8), and Rickenmann's estimate (1997, equation 5). Extreme events such as the 1978 one in Palagnedra come close to the upper limit for coniferous forests according to Uchiogi et al. (1996). For Swiss conditions with catchment areas EG <300 km², coefficients up to $C \approx$ 400 in equation (8) appear realistic as initial indications or an extreme flood event.

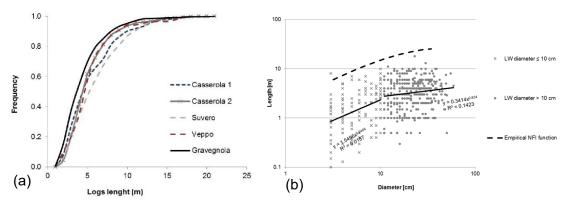
(a) Frequency distribution of trunk lengths that were deposited in different Italian river channels after a flood (Lucía et al. 2015); (b) Comparison of trunk lengths and diameters of transported trees during floods with the empirical NFI equation (relationship between stem length and diameter at breast height) (Steeb et al. 2016).

Flow depth and river width can also limit the maximum transportable trunk lengths. However, past flood events show that LW can also exhibit quite large dimensions (**Figure 20a, Figure 21**). Especially when landslides occur into a reservoir, trunk lengths are not much reduced. In many cases, large trunks or roots are sufficient to block the cross section of a dam spillway and initiate obstructions. For this reason, trunk lengths of up to 25 m were taken into account in the hazard assessment of the Swedish Trängslet reservoir (Boes et al. 2013). In order to estimate the hazard potential or the blocking probability (section 5th3), tree dimensions near banks or near reservoirs should therefore be used.

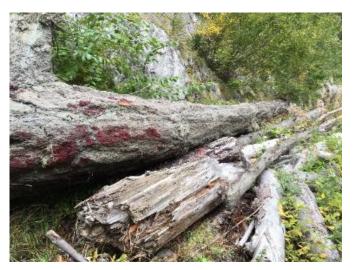
Figure 21: Large wood with trunk lengths of up to 15 m, which was removed from Gebidem reservoir (Photo: VAW).

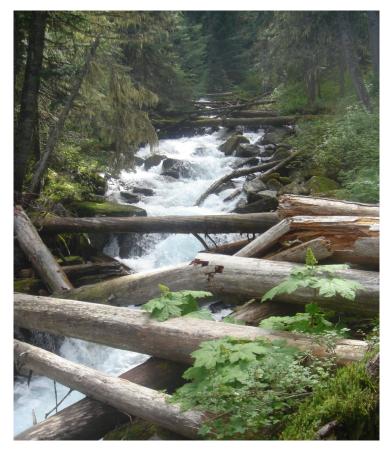
Figure 22: Mountain torrent in Joffre Lake Provincial Park, British Columbia, Canada (Photo: Boes 2009).

Reservoir tributaries have a further influence on LW supply. In the Alpine region, streams are often narrow and/or feature gorges with steep banks. Trees that have fallen into the riverbed can remain in the water for years and prevent additional wood from being transported downstream (**Figure 22**). In the case of a flood, accumulated wood could suddenly break loose and be carried away into the reservoir (see Palagnedra case study).

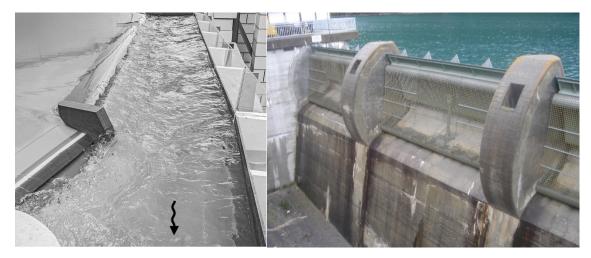
Figure 24: Flood spillway inlet structure in a collecting channel with flaps. Left: top view of a dam spillway model of the Trängslet Dam in Sweden with single-bay flap gate at the downstream side of the weir (Lucas et al. 2015); right: multiple-bay weir with flap gates and flow disturber at the Punt dal Gall dam (Photo: Boes, 2009).

One way to minimize obstructions due to LW is to ensure sufficiently large dimensions at the dam spillway inlet structures. The guidelines for width and height dimensions according to chapter 3 can be used as a design specification. An unregulated dam spillway (e.g. free overflow) has a smaller risk of getting obstructed than a regulated dam spillway under identical conditions. Although trunks can be deposited on the weir crest at low flow depths (see chapter 5.3.2), they are usually removed with increasing discharge. Intermediate pillars, flaps, vertical gates, weir bridges, etc. generally increase the likelihood of obstruction. However, the type of regulating structure also has an influence on the likelihood of obstruction. Undercurrents (e.g. at vertical lifting / lowering gates) are to be avoided in critical conditions, whereas overflowable regulating structures such as flaps, drum and sector weirs tend to be less susceptible to obstructions. Such regulating structures may even be advantageous because overflows can be directed and concentrated at the center of dam spillway inlet structures. These structures may be able to loosen blocked single trunks due to the high hydrodynamic forces (Hartung & Knauss 1976). Flaps are advantageous for producing locally larger flow depths which reduce the likelihood of wood blocking (Boes et al. 2013, Figure 24).

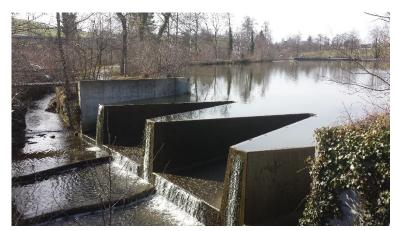
Figure 25: Spillway inlet structure in the form of a labyrinth weir with a large over-flow crest and clearance width at Sternenweiher (Canton of Zurich, Switzerland) (Photo: Boes, 2015).

- Removal of dividing pillars to increase the clearance width of the weir bay (e.g. Reservoir Gstins, see Annex 2);
- Remove or relocate weir bridge to increase clearance height (Palagnedra Reservoir, see Figure 10);
- Removal of movable regulation structures and replacement by a fixed but longer overflow weir crest (**Figure 25**).

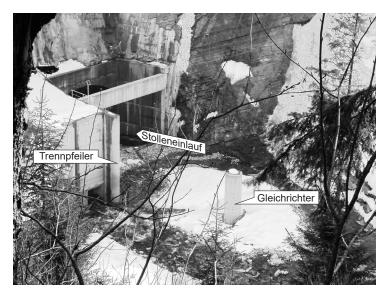
Figure 26: Rectifier in front of the bypass tunnel on the Rovana River, Switzerland (Lange & Bezzola 2006).

According to Hartung & Knauss (1976) and Hartlieb (2015), LW can also be retained by means of a single or several pillars, or aligned longitudinally and thus discharged via the dam spillway. **Figure 26** shows such a rectifying pillar in front of a bypass tunnel on the Rovana (Canton of Ticino, Switzerland). The pillars should be built with sufficient distance to the dam spillway. Since the pillar shape has little effect on the effectiveness of aligning woods, a circular cylindrical pillar is advisable for cost and construction method reasons (Waller et al. 1996).

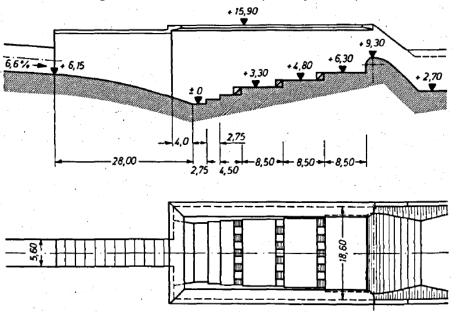
Figure 27: Example of a spatial stilling basin (Hartung & Knauss 1976)

The energy dissipation structure must also be considered for the passage of LW. LW transported at high flow velocities would damage the internal protrusions in stilling basins, such as various obstructions and rows of blocks. Hartung & Knauss (1976) recommend spatial (three-dimensional) stilling basins with an ascending base in the direction of flow (**Figure 27**). Chute blocks at the end of the inlet channel leading to the stilling basin usually do not pose problems regarding LW, since they are flush with the bed at their upstream end so that any debris is transported over them. However, there are abrasion and damage hazards due to LW especially on steps and end sills.

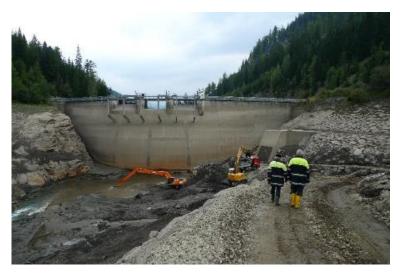
Figure 28: Large wood rack at the Paalbach dam in Austria (Photo: Federal Ministry of Agriculture, Forestry, Environment and Water Management Austria).

The clear bar spacing of LW racks should not be too small. Small pieces of wood and finer material which are not critical for the dam spillway should not be retained. However, large trunks exceeding the dimensions of the smallest clearance of the dam spillway should be blocked at the racks. According to Lange & Bezzola (2006), it can be assumed as a guideline that wood with a length of $L \ge 1.5 \cdot s$ can be retained at a rack with a clear bar spacing of s.

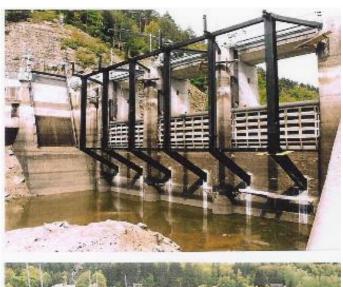
Figure 29: Large wood rack at the Thurnberg reservoir at RiverKamp in Austria (Photo: Federal Ministry of Agriculture, Forestry, Environment and Water Management Austria).

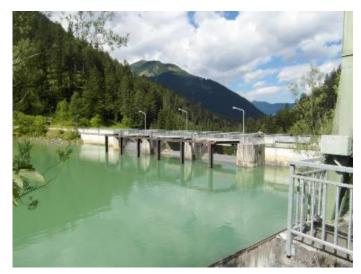
Figure 30: Upstream large wood rack at Rotlech Dam in Austria (Photo: Federal Ministry of Agriculture, Forestry, Environment and Water Management Austria).

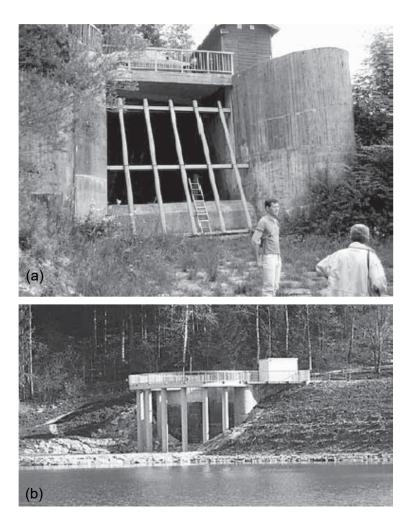
Figure 31: a) Old spillway with large wood rack at Grüntensee and b) new upstream rack pillars (Photo: Hartlieb 2015).

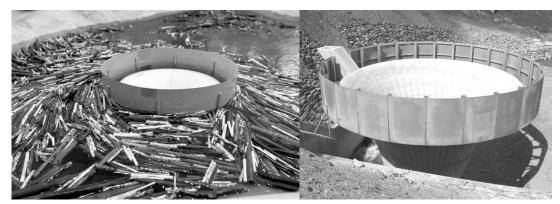
Figure 32: Bell mouth spillway with skimming wall in debris retention basin at the Kelchbach in Naters, diameter of approximately 14 m. Left: Model Experiment; right: Prototype (Photos: Lange & Bezzola 2005).

As an alternative to the use of racks, LW can be retained by means of scum boards or skimming walls. Installation of an upstream skimming wall has proven to be a suitable measure to prevent the entry of wood into the bell mouth spillway at the Kelchbach in Naters, Switzerlan (**Figure 32**).

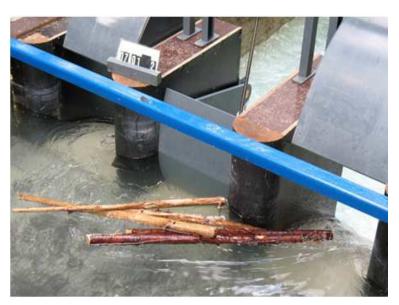
Figure 36: Obstruction at opened weir bays of a three-bay weir system (Hartlieb 2015)

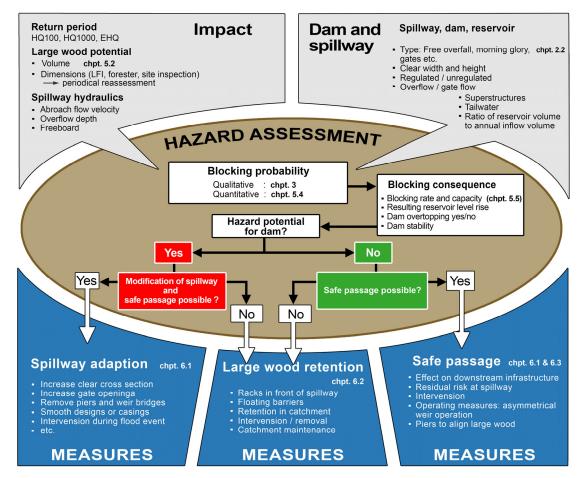
Figure 37: Hazard assessment diagram regarding floating debris at dam spillways.

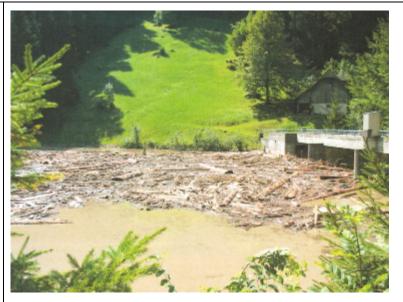
Figure 2: Dam spillway obstruction due to large wood during the 2005 flood (Source: EW Nidwalden)

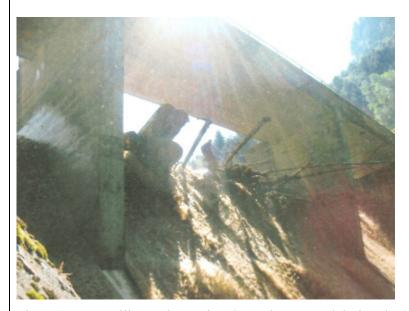
Figure 3: Dam spillway obstruction due to large wood during the 2005 flood event (Source: EW Nidwalden)

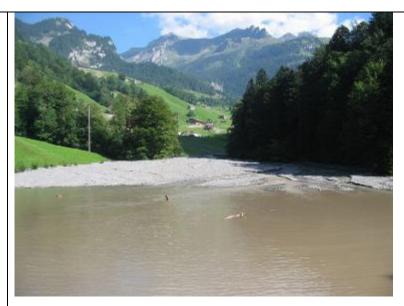
Figure 4: Sediment deposits in the Käppelistutz reservoir after the 2005 flood event (Source: EW Nidwalden)

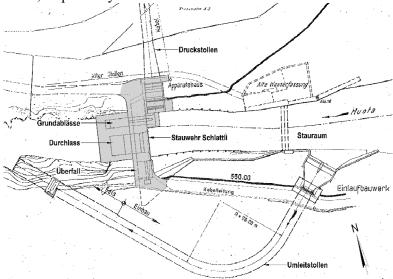
Figure 1: Schlattli weir overview (Source: ebs Energie AG)

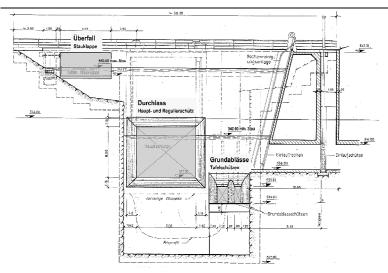
Figure 2: Upstream view of Schlattli weir (Source: ebs Energie AG)

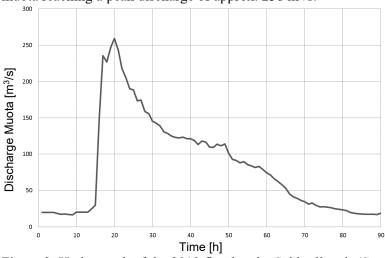
Figure 3: Hydrograph of the 2010 flood at the Schlattli weir (Source: ebs Energie AG)

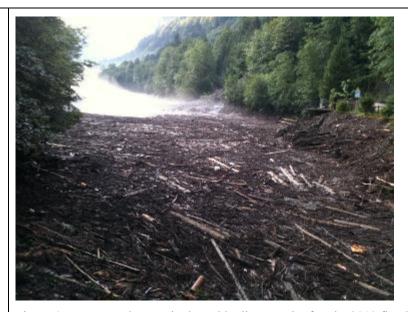
Figure 4: Large wood carpet in the Schlattli reservoir after the 2010 flood event (Source: ebs Energie AG)

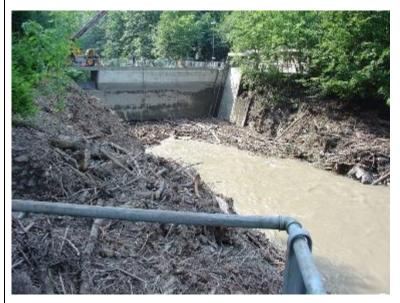
Figure 5: Outlet obstruction due to large wood after the flood in 2010 (Source: ebs Energie AG) $\,$

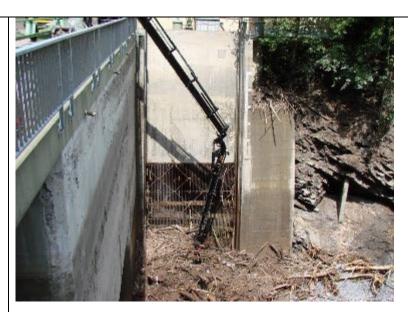
Figure 6: Mechanical removal of large wood at the water intake after the 2010 flood event (Source: ebs Energie AG)

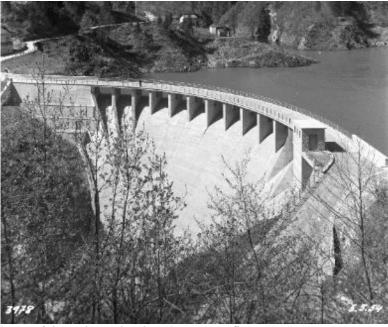
Figure 1: Old spillway of the Palagnedra dam (Source: Ofima 1954)

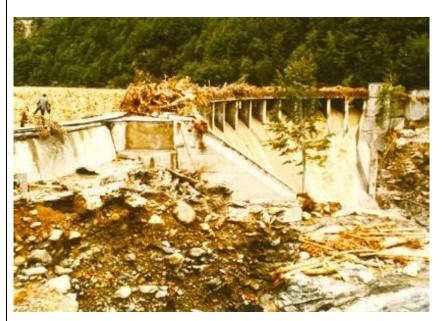
Figure 3: Dam spillway obstruction due to large wood and partially eroded core wall after the 1978 flood event (Source: Ofima)

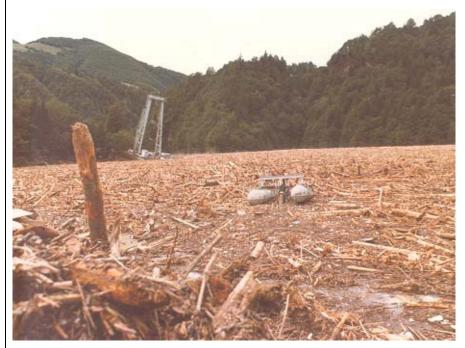
Figure 4: Large wood deposition in reservoir after the 1978 flood event (Source: Ofima)

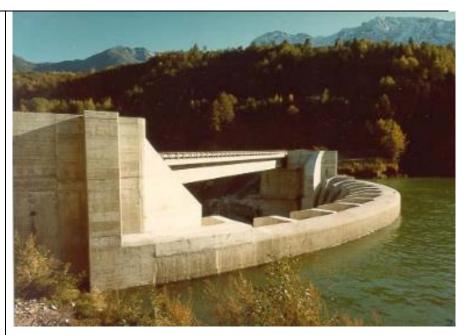
Figure 5: New dam spillway without pillars and with new bridge (Source: Ofima)

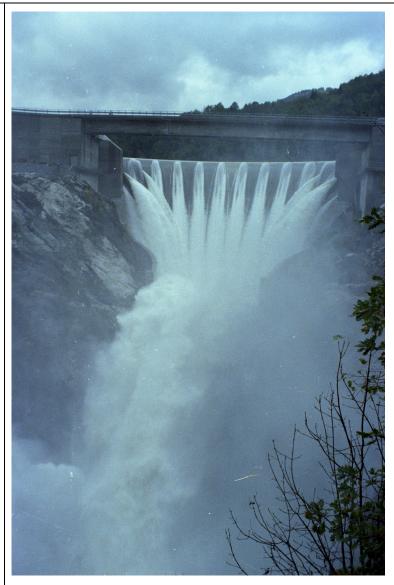
Figure 6: New dam spillway in operation (Source: Ofima)

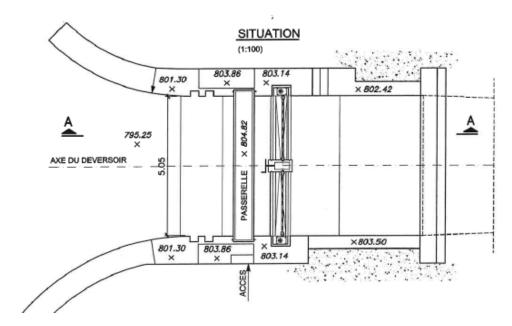
Figure 1: Overview of bypass tunnel equipped with sliding gates

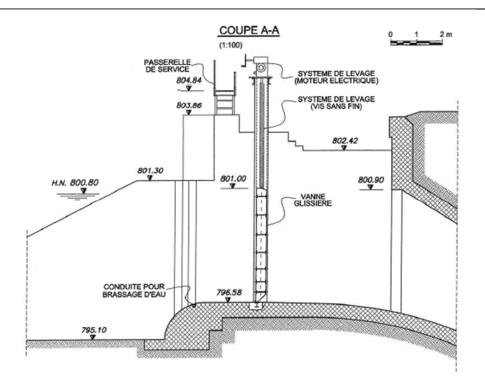
Figure 2: Cross section of bypass tunnel equipped with sliding gates

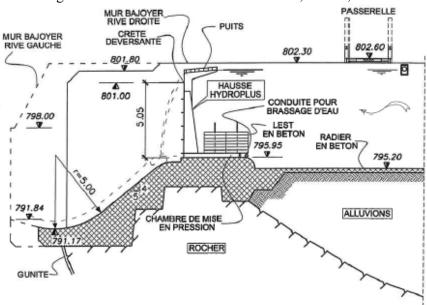
Figure 3: Cross section of the overflow equipped with fuse gates

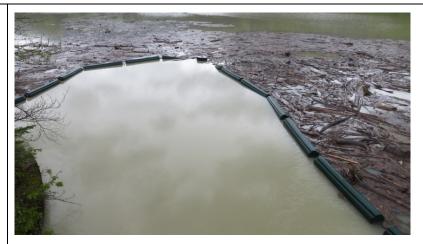
Figure 4: Situation before the floating barrier breach of May 2015

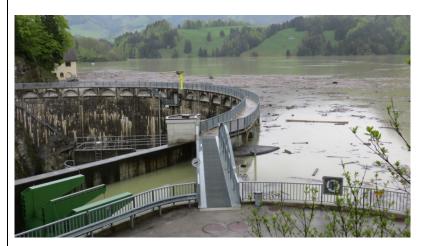
Figure 5: Large wood volumes at Montsalvens reservoir during a flood

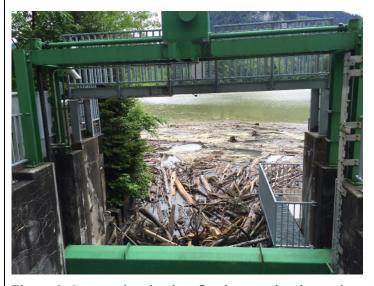
Figure 6: Current situation in a flood event; the obstructions risk remains unacceptably high

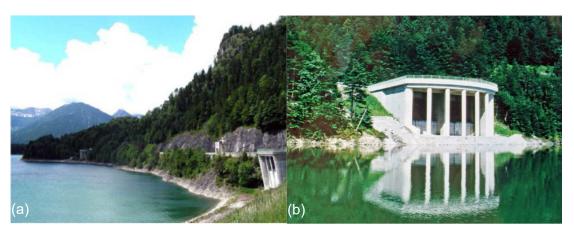
Figure 38: (a) Old and (b) new spillways of the Sylvenstein reservoir with upstream wood rack (Photos: Hartlieb 2014)

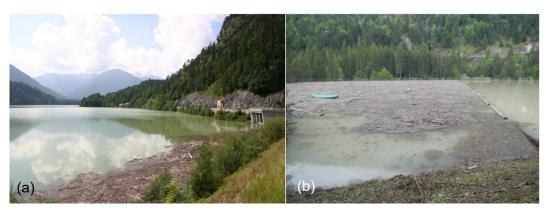
(a) Large wood during the floods of August 2005 (Photo: A. Hartlieb) and (b) Large wood barriers during the floods in June 2013 (Photo: Bavarian State Office for the Environment)

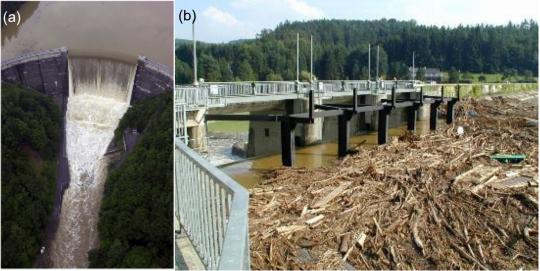
(a) Dobra reservoir with free spillway overflow and (b) Large wood at the rack of the Thurnberg reservoir spillway during the 2002 flood event (Photos: Federal Ministry of Agriculture, Forestry, Environment and Water Management, Austria).

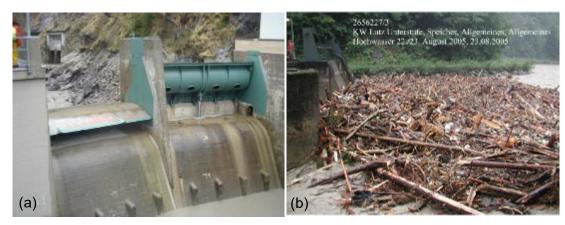
Figure 41: Gstins reservoir: (a) Dam spillway with two flap gates (Photo: VAW) and (b) obstruction during the 2005 flood event (Photos: Vorarlberger Illwerke AG).
